SOLID PARTICLE EROSION PROCESSES IN
COATINGS AND COMPOSITE MATERIALS

Joseph Zahavi
Israel Institute of Metals
Technion
Haifa, Israel

May 1981

Technical Report for period April 1980 - March 1981

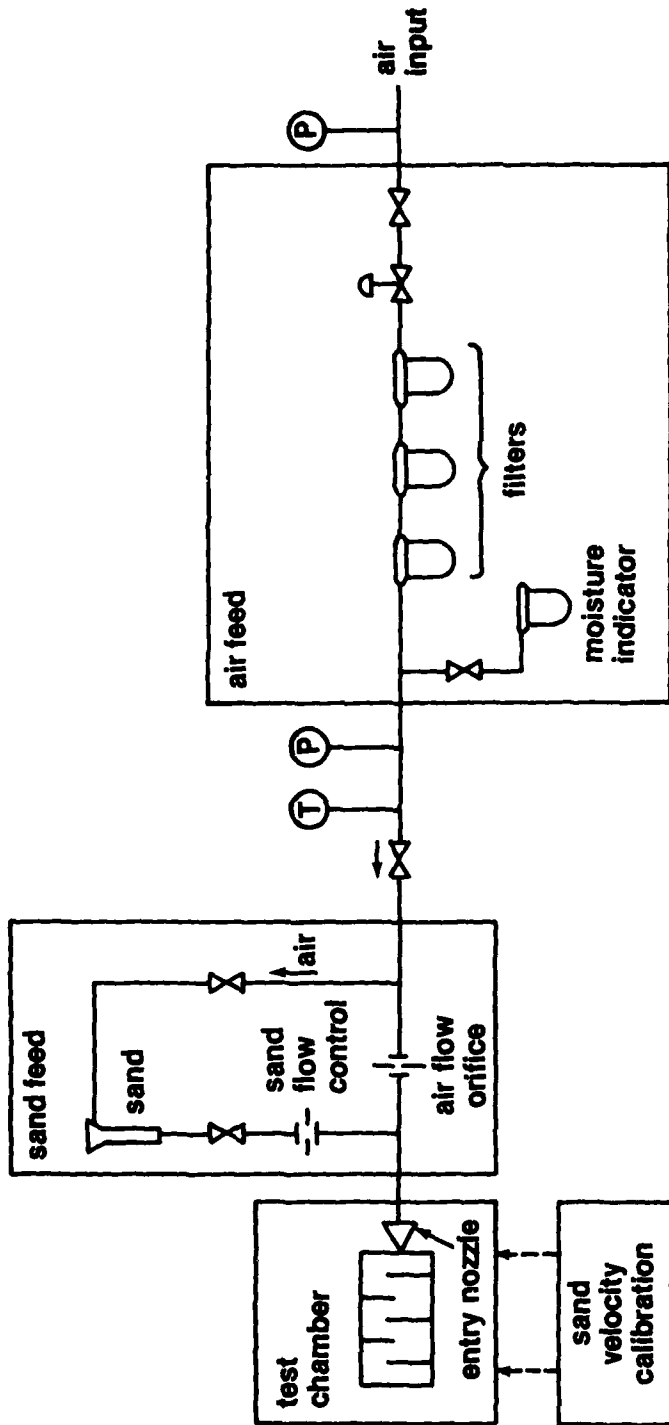
Fig. 2.1 Schematic Drawing of the Air Blast Erosion Rig

The sand reservoir was filled with sand in amounts varying between 50 and 600 gr and the experimental run continued until all the sand had been exhausted from the reservoir. The maximum air velocity used was 150 m/sec. and the specimen impact angles were 90° , 75° , 60° , 45° , 30° and 15° . Three to five runs were made for each experimental condition of air velocity, impingement angle, sand quantity and target. Before and after exposure the specimens were weighed to 0.1 mg on an analytical balance.

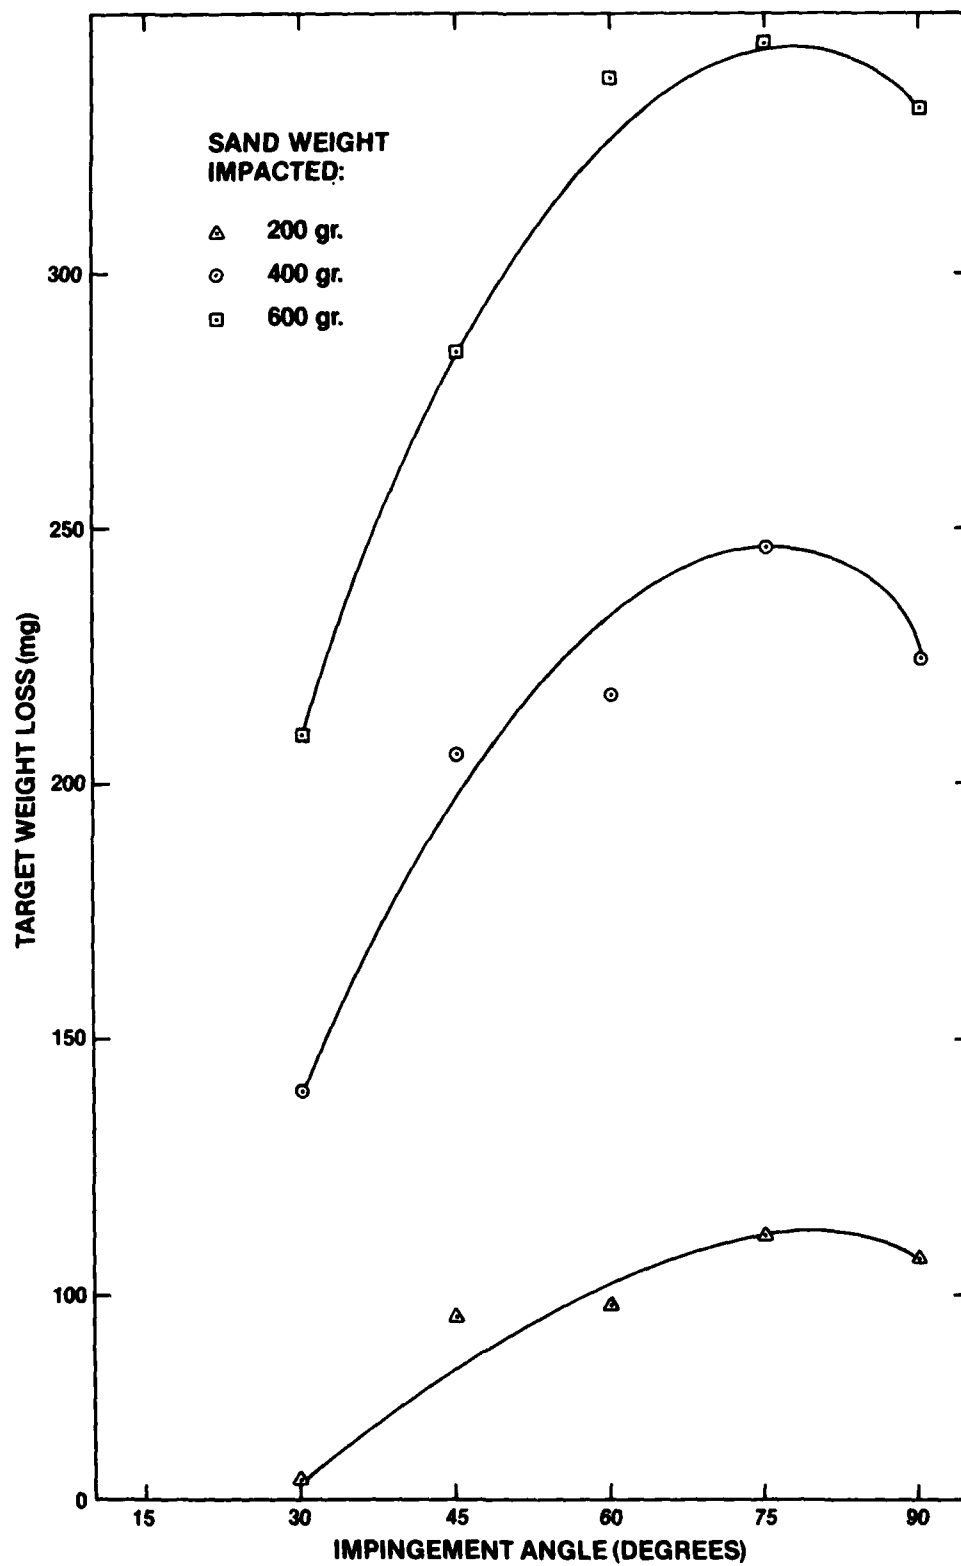
Fig. 3.1 Weight Loss of Quartz-Polyimide as a Function of Impact Angle

impact angle up to 75° where a maximum weight loss was found in Quartz polyimide (Figure 3.1), Glass Epoxy (Figure 3.3), and Quartz Polybutadiene (Figure 3.4). This behavior was observed with constant amounts of 200 gr, 400 gr, and 600 gr of abrasive sand. Particles impacted on the target surface resulted in weight loss in the range of hundreds of milligrams up to 500 mg. (Figures 3.1, 3.3, 3.4). The behavior of E-Glass Epoxy material (AFWAL/MLBE) under the same erosion conditions used with the above composite materials is shown in Figure 3.2. Increase in impact angle resulted in increased target weight loss up to a maximum at 60° , 45° and 45° for impacted sand amounts of 200 gr, 400 gr, and 600 gr, respectively (Figure 3.2). After reaching a maximum, target weight loss decreased to a minimum at normal impact angle. Furthermore, in the case of E-Glass/Epoxy (AFWAL/MLBE), the weight loss was in the range of tens of milligrams compared to hundreds found in the other composite materials.

The composite materials investigated (namely, Quartz polyimide, Glass Epoxy (RAFAEL) and Quartz polybutadiene) showed maximum erosion or weight loss at impact angles of 75° to 90° with 200 to 600 gr sand weight impacted (Figure 3.1, 3.3, 3.4). Minimum weight loss in these materials was found at the lowest impact angle of 30° . The data of target weight loss vs impact angle suggest therefore that the composite materials investigated behave as brittle materials under the sand erosion condition used in this research work. This is in keeping with their properties as thermosetting resins and inorganic fibers.

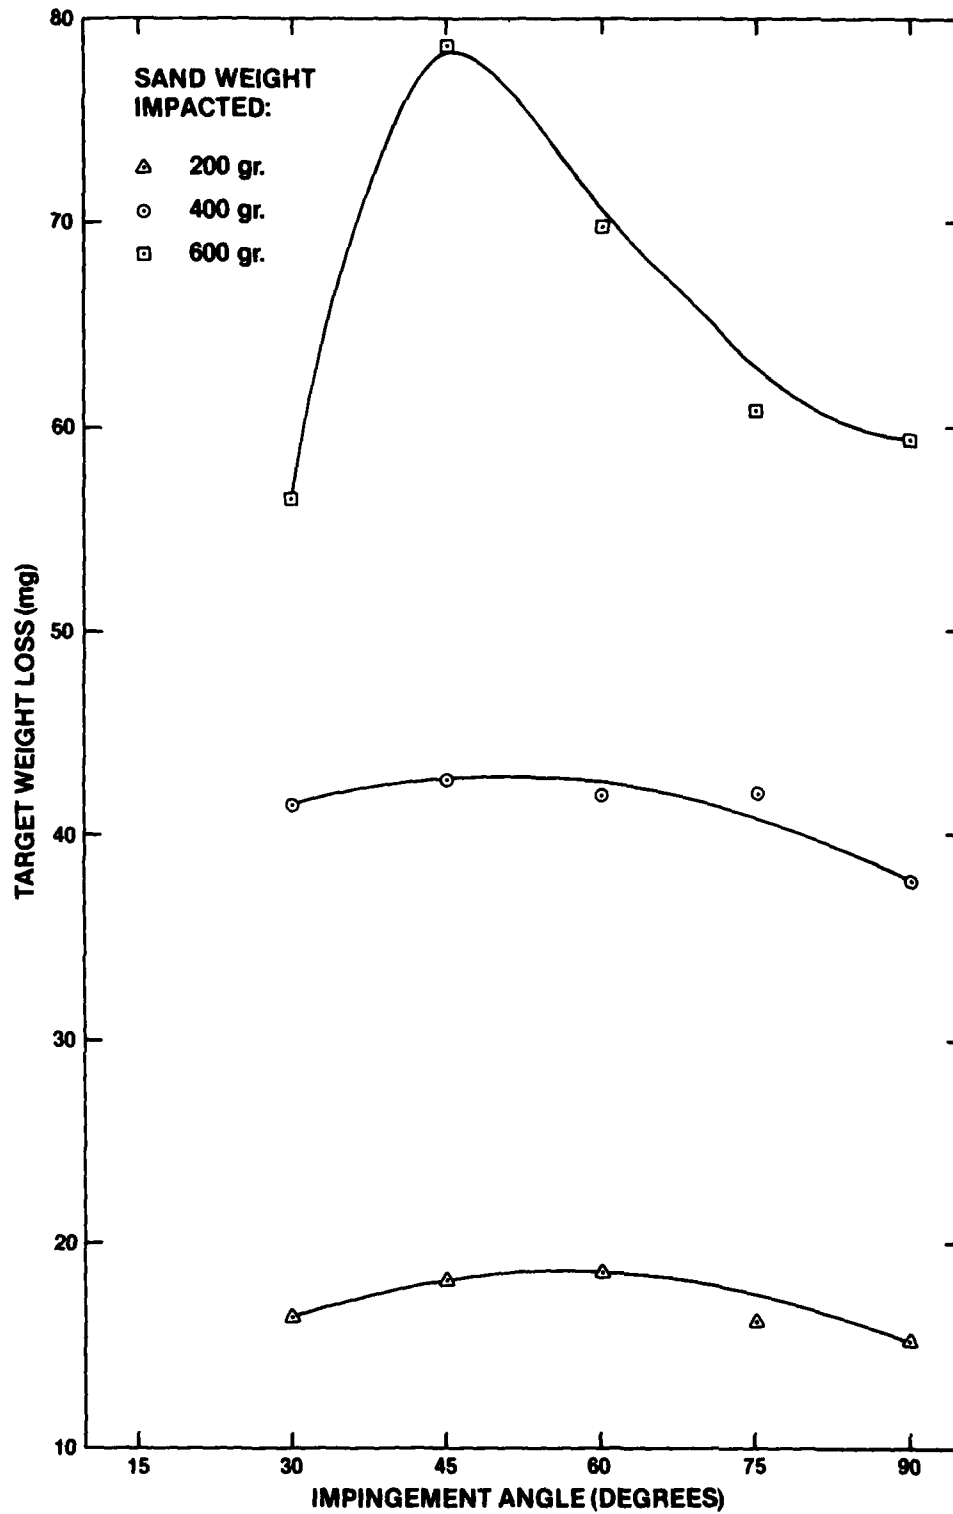
Fig. 3.2 Weight Loss of AFWAL/MLBE E-Glass Epoxy as a Function of Impact Angle

as semi-ductile. In other words, maximum weight loss was obtained at impact angles around 45° for amounts of 200 gr, 400 gr, and 600 gr sand particles (Figure 3.2). Moreover, the weight losses of the E Glass Epoxy observed under these erosion conditions were lower by about one order of magnitude compared to values obtained in the other composite materials tested. This difference is likely due to the presence of higher percentage of glass fibers, better adhesion between the fibers and the resin as well as less porosity in the resin matrix.

semi-ductile type behavior of the E Glass Epoxy target material (Figure 3.2) as was observed.

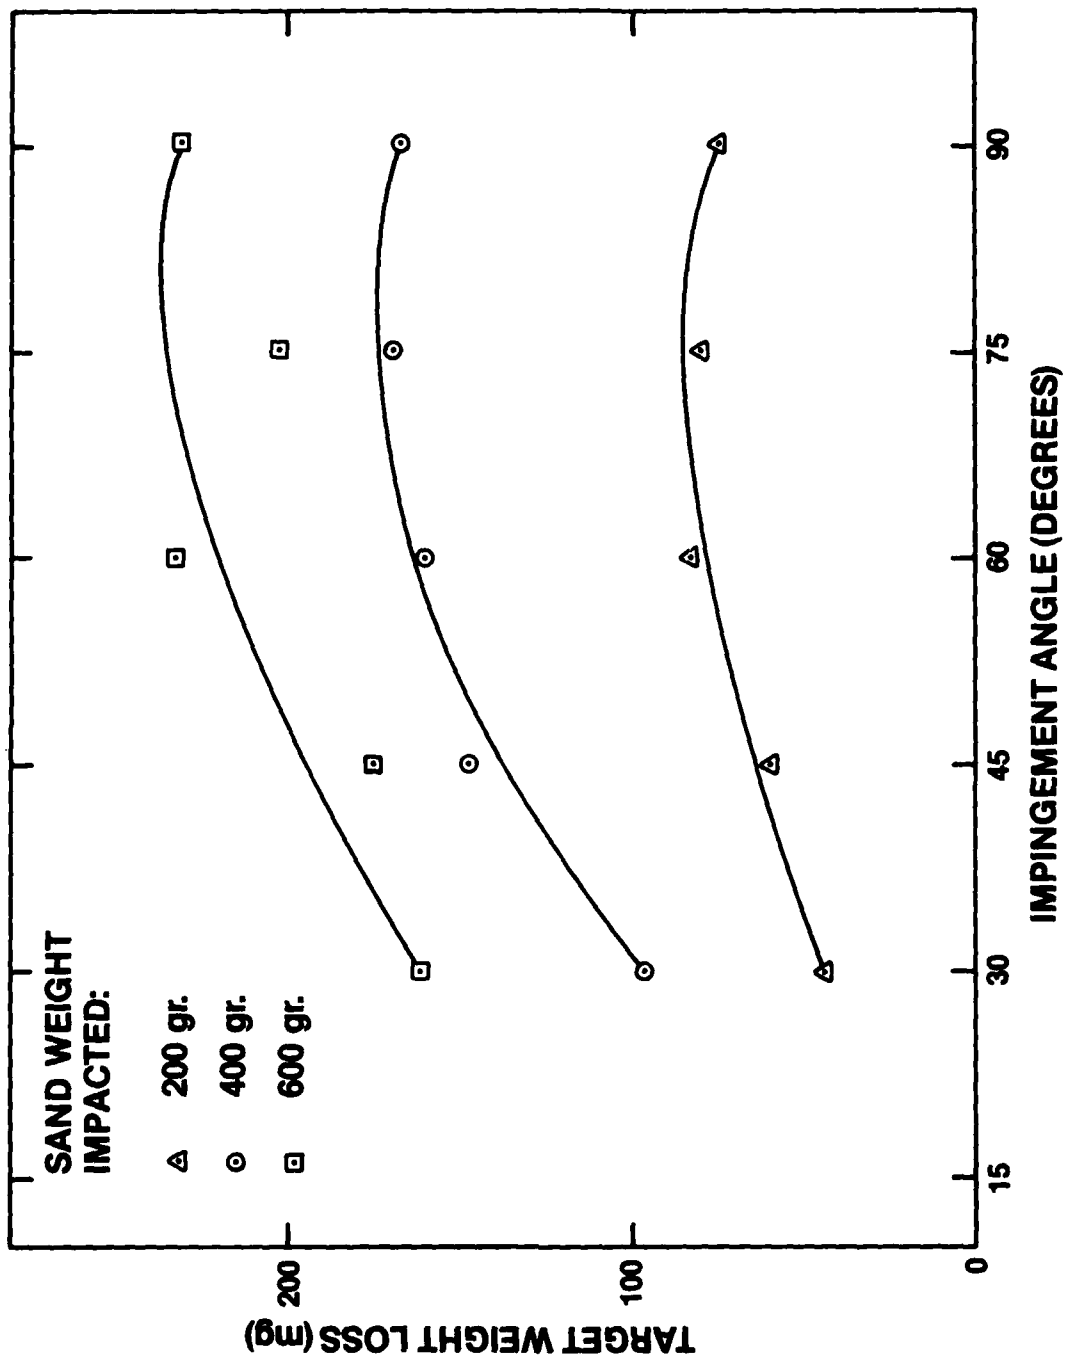
Fig. 3.3 Weight Loss of RAFAEL Glass Epoxy as a Function of Impact Angle

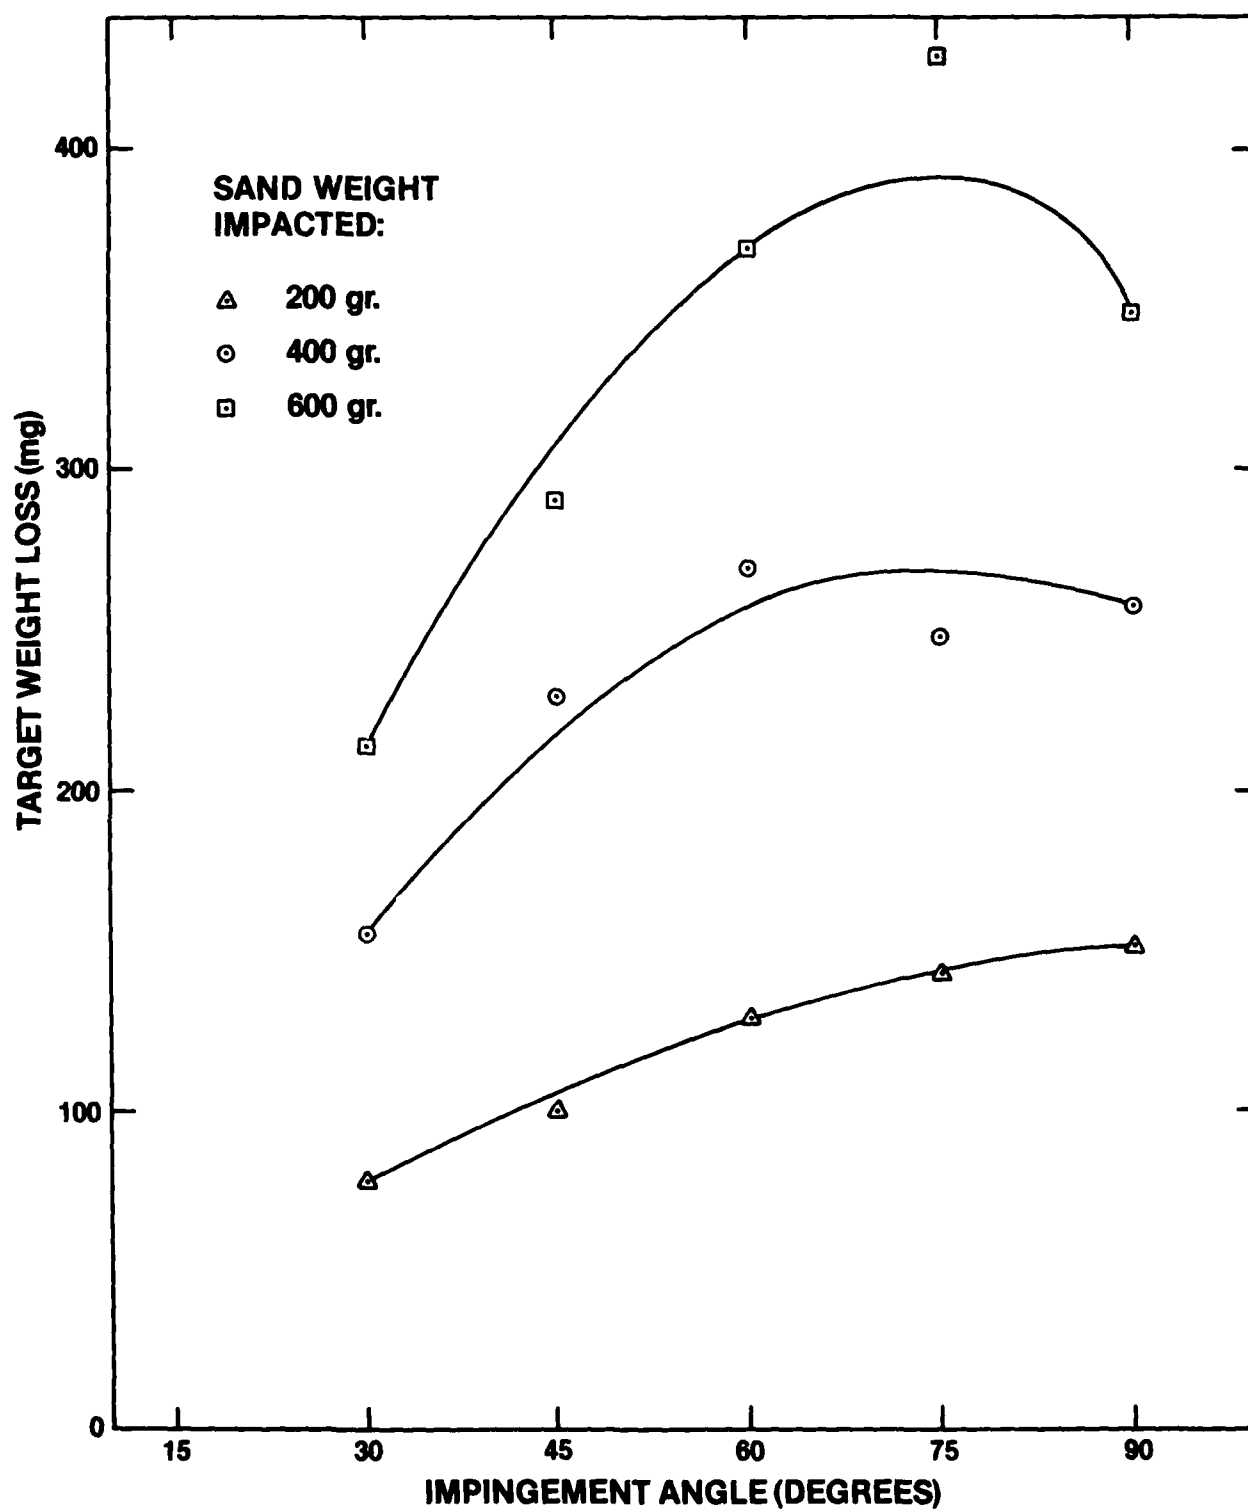
Fig. 3.4 Weight Loss of Quartz-Polybutadiene as a Function of Impact Angle

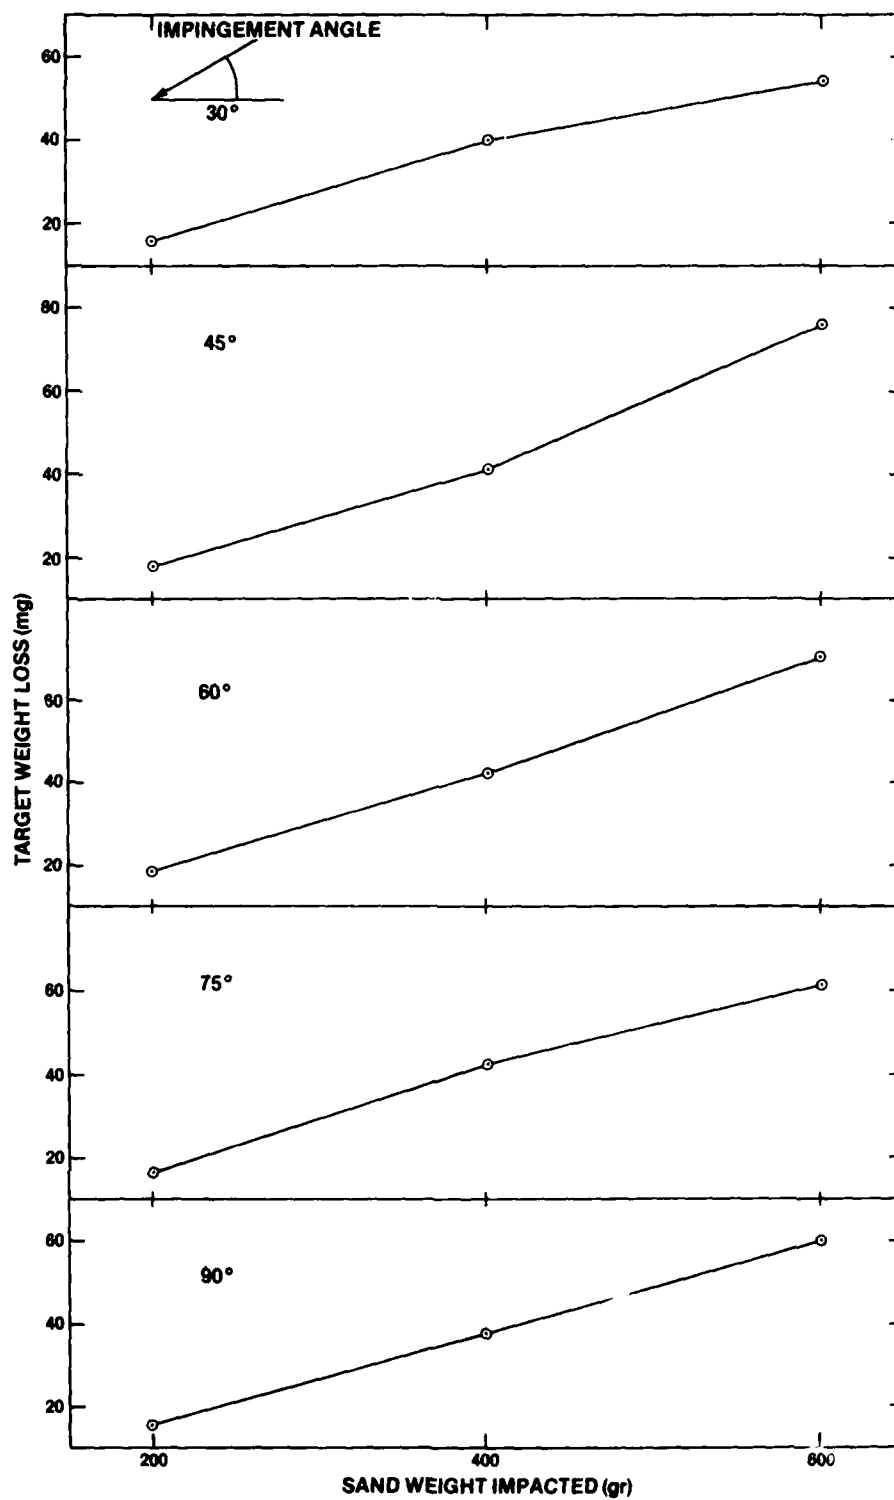
Fig. 3.5 Weight Loss as a Function of Sand Weight Impacted for Quartz-Polyimide

The dependence of target weight change on amounts of sand impacted under constant impact angles for the composite material is described in Figures 3.5, 3.6 and 3.7. It was found that an increase in the amount of sand weight impacted resulted in progressive target weight losses under all impact angles investigated as can be seen in Figure 3.5 for Quartz Polyimide, Figure 3.6 for E Glass-Epoxy (AFWAL/MLBE) and Figure 3.7 for Quartz Polybutadiene and Glass/Epoxy (RAFAEL). Although the E Glass/Epoxy (AFWAL/MLBE) materials behaved similarly to the other materials under the same erosion condition, the amounts of

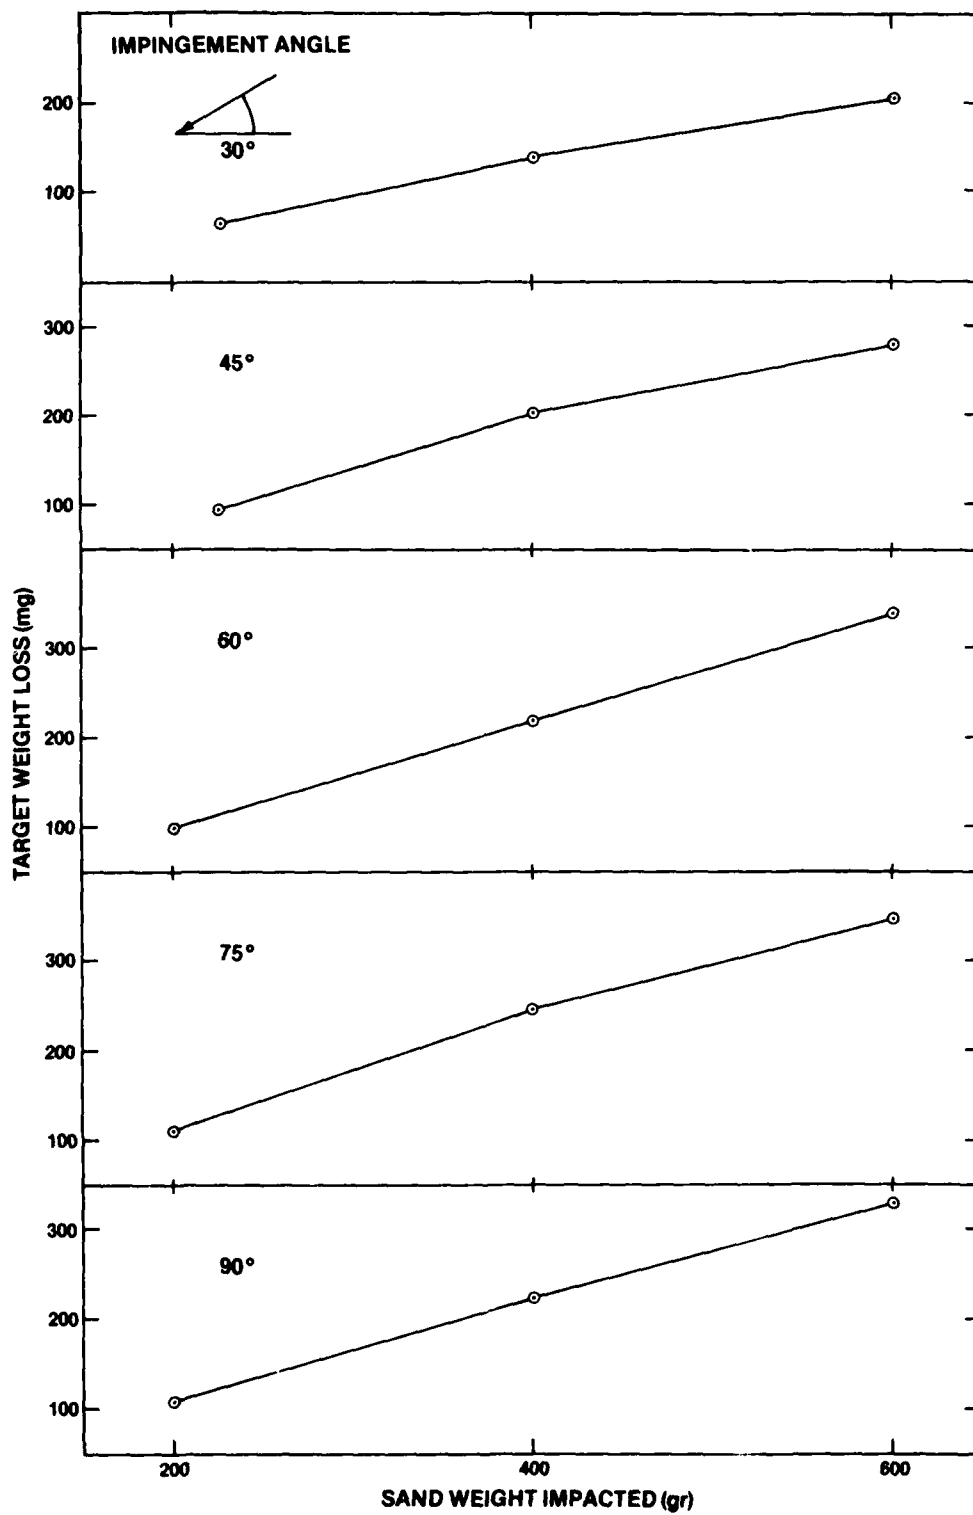
Fig. 3.6 Weight Loss as a Function of Sand Weight Impacted for E Glass Epoxy

target weight losses for it were found to be in the range of 80 mg. (Figure 3.6) compared to the range of 500 mg; that is, an order of magnitude lower than the others (Figure 3.5 for Quartz-polyimide and 3.7 for Glass Epoxy (RAFAEL) and Quartz polybutadiene). Furthermore, it was found that the increase of target weight loss with increase of sand weight impacted took place at low as well as high impact angles.

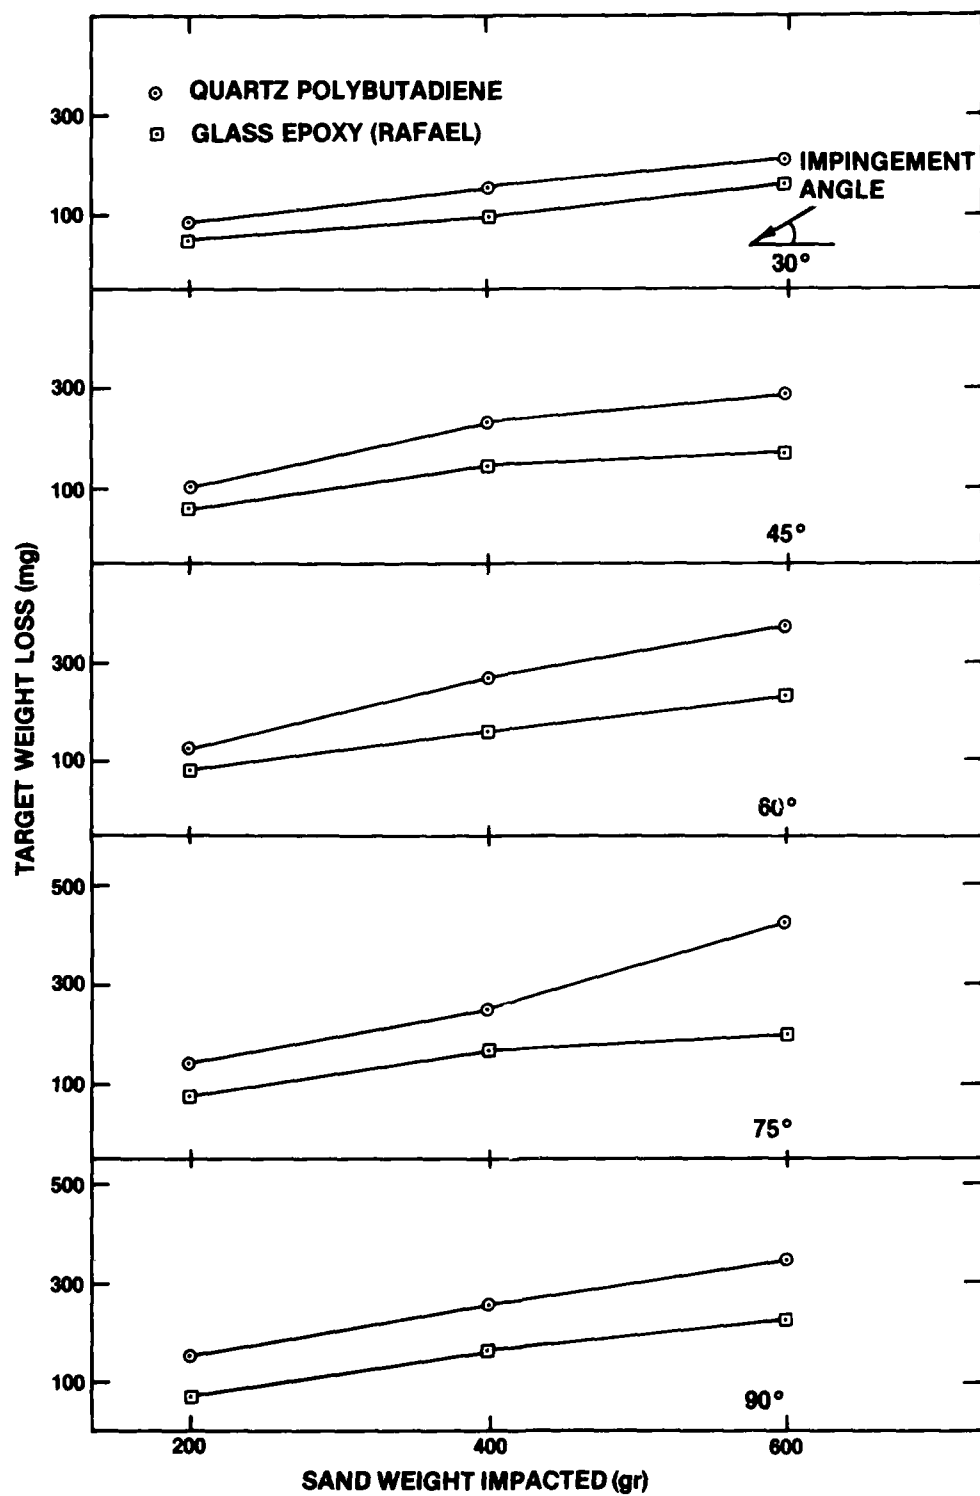
Fig. 3.7 Weight Loss as Function of Sand Weight Impacted for Quartz-Polybutadiene

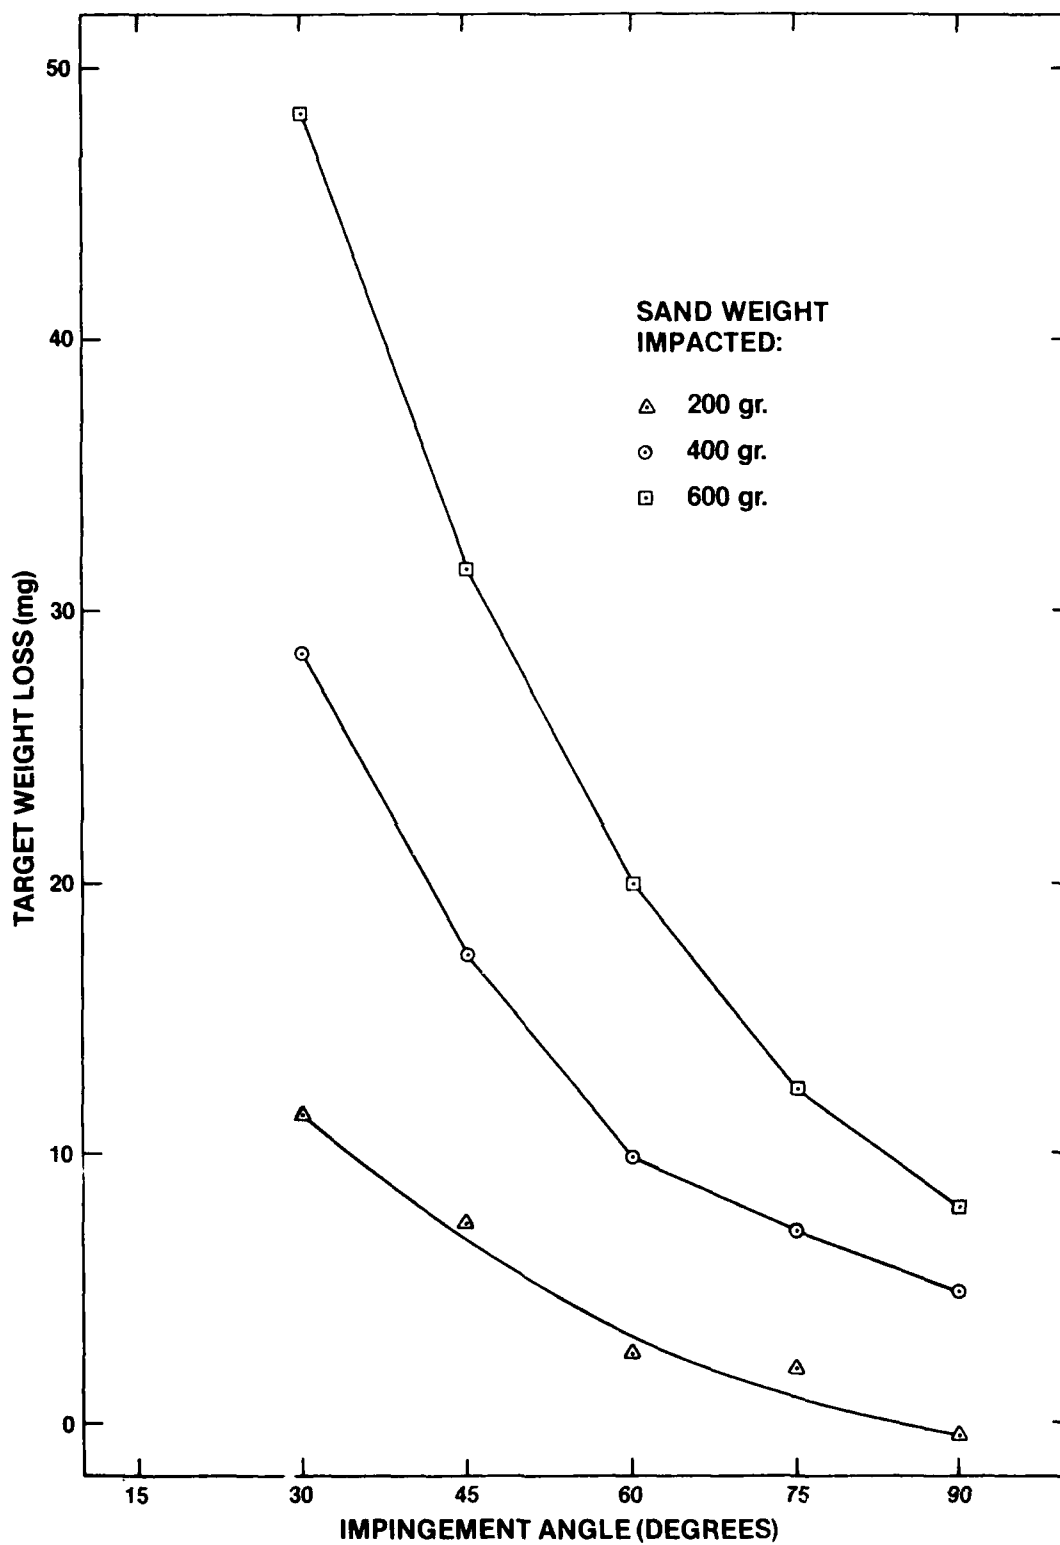
Fig. 3.8 Weight Loss of MIL-C-83286 Polyurethane E Glass-Epoxy as a Function of Impact Angle

The dependence of coating target weight change on impingement angles before and after being exposed to sand erosion conditions is shown graphically in Figures 3.8, 3.9 and 3.10 as well as in Appendix B, Tables B.1-B.3. Figure 3.8 shows the behavior of MIL-C-83286 polyurethane coatings on E Glass Epoxy substrate under the impact of 200, 400, and 600 gr abrasive and particles on the target surface. A correlation between target weight loss and impingement angle was found (Figure 3.8). Maximum weight loss was found at low impact angle resulted in decreasing target weight loss which was around 80% for normal impact angle and all the amounts of sand particles weight impacted (Figure 3.8). The

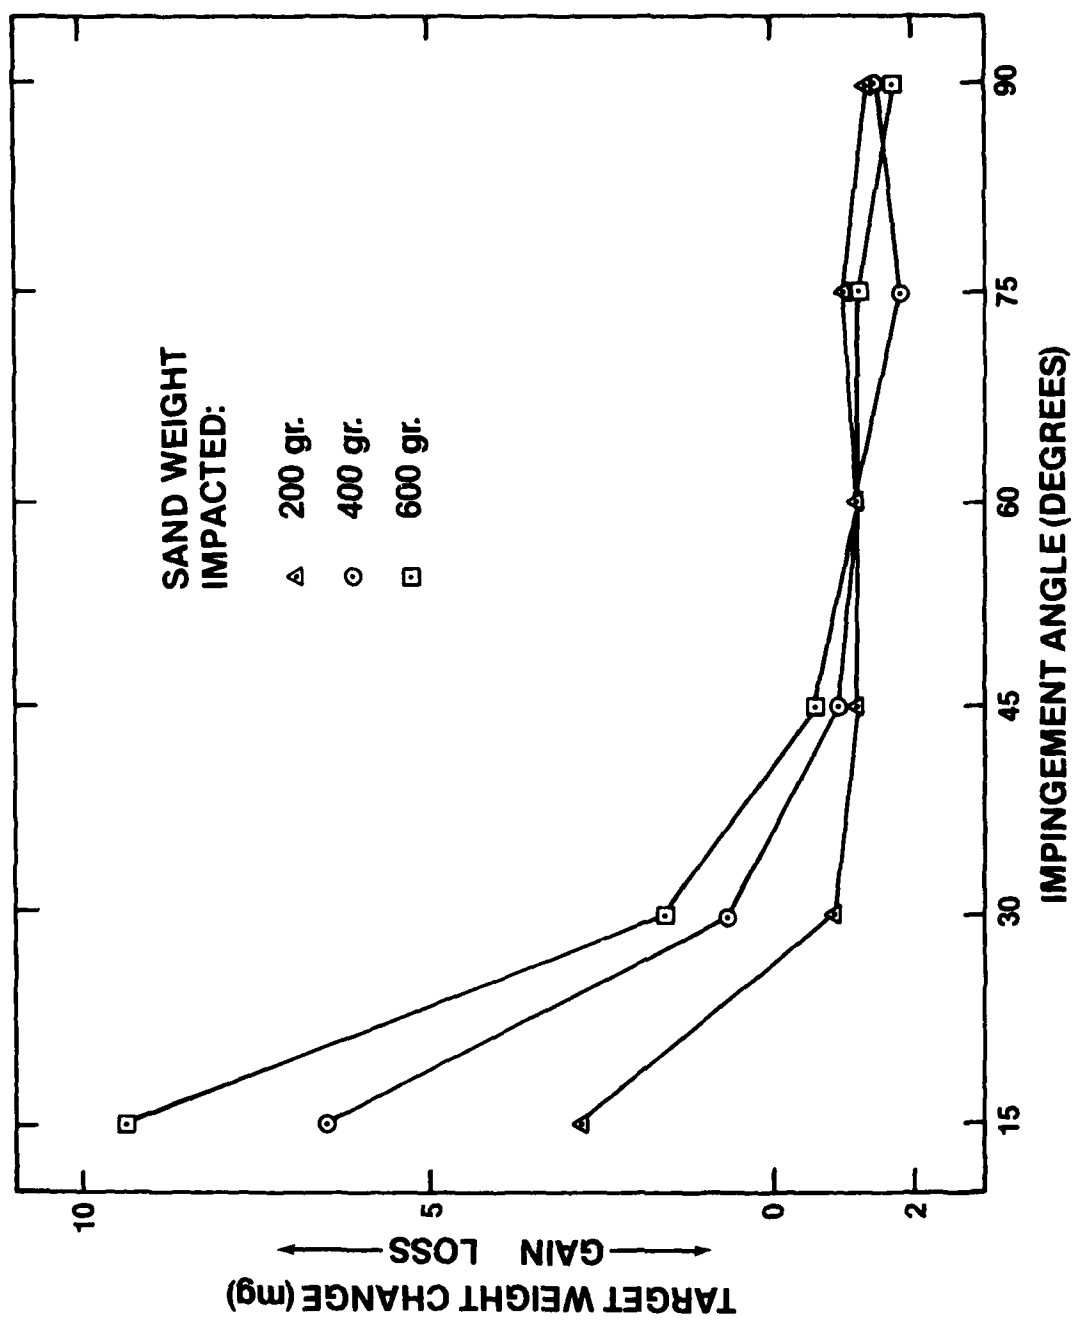
Fig. 3.9 Weight Change of MIL-C-8323 1 Polyurethane on E Glass-Epoxy as a Function of Impact Angle

behavior of MIC-C-83231 polyurethane coating on E-Glass Epoxy substrate under erosion conditions is shown in Figure 3.9. It was found that under constant amount of sand particles impacted (200, 400, 600 gr, respectively), a maximum target weight loss was obtained at low incidence angle of 15° . Increasing the impact angle up to 45° resulted in reduced target weight loss. Furthermore, at impact angles of 45° and higher, target weight gain was found to be constant and practically independent of the impact angle (See Figure 3.9).

As long as the coatings remain intact, the protection at 90° is excellent; however, if failure occurs, then erosion of the composite will be extreme. By contrast, at the low angles the resistance of the coatings is reduced (See Figure 3.9 and 3.10) but the relative resistance of the composite is greater so that erosion would not be as catastrophic if coating failure occurred.

When erosion rate was found to be negligible at impact angles of 45° to 90° (Figures 3.9, 3.10) the surface roughness was also found to be of minimum value (Figures 3.15, 3.16). These low values of erosion rate together with minimum values of surface roughness are in accordance with the coatings surface morphology. At these conditions no removal of coatings pieces occurred resulted in relative uniform smooth coating surfaces (Figures 3.26B, 3.27, 3.28B).

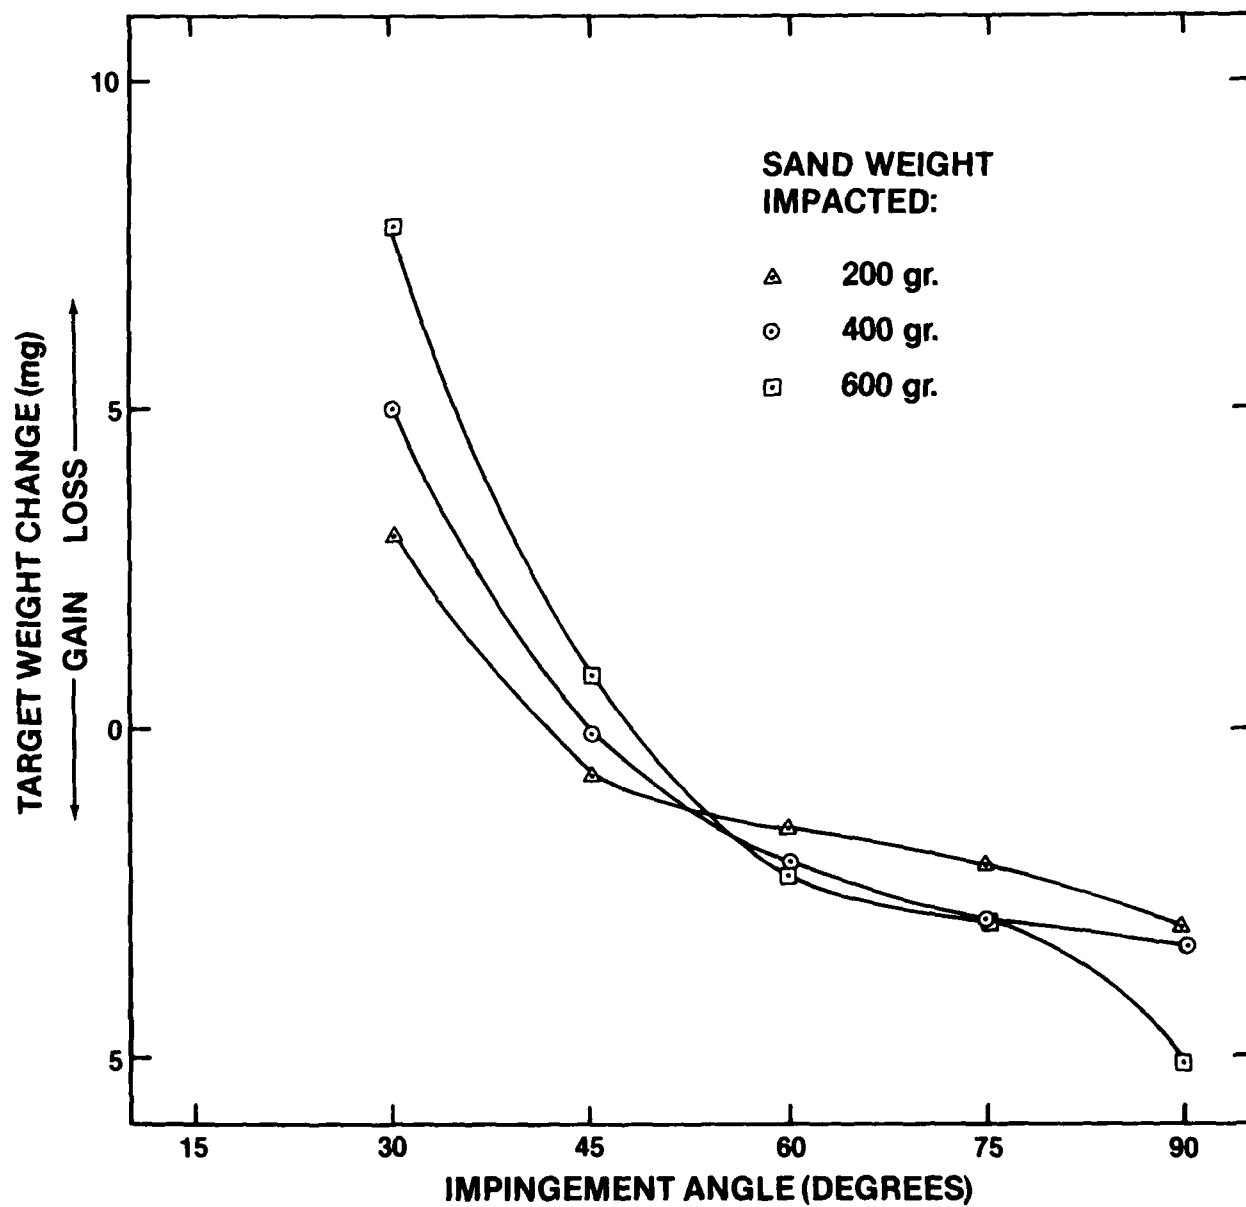
Fig. 3.10 Weight Change of AF-C-VBW-15-15 Fluorocarbon on Quartz-Polyimide as a Function of Impact Angle

In Figure 3.10 the behavior of AF-C-VBW-15-15 fluorocarbon coatings on quartz polyimide under erosive conditions is shown. Target weight change as a function of impingement angle was obtained under constant amounts of 200 gr, 400 gr, and 600 gr of sand particles impacted. Maximum target weight loss was obtained at impact angle 30° ; whereas at around 50° a zero weight loss was observed. Increasing the impact angle from 50° up to 90° led to target weight gain as can be seen in Figure 3.10.

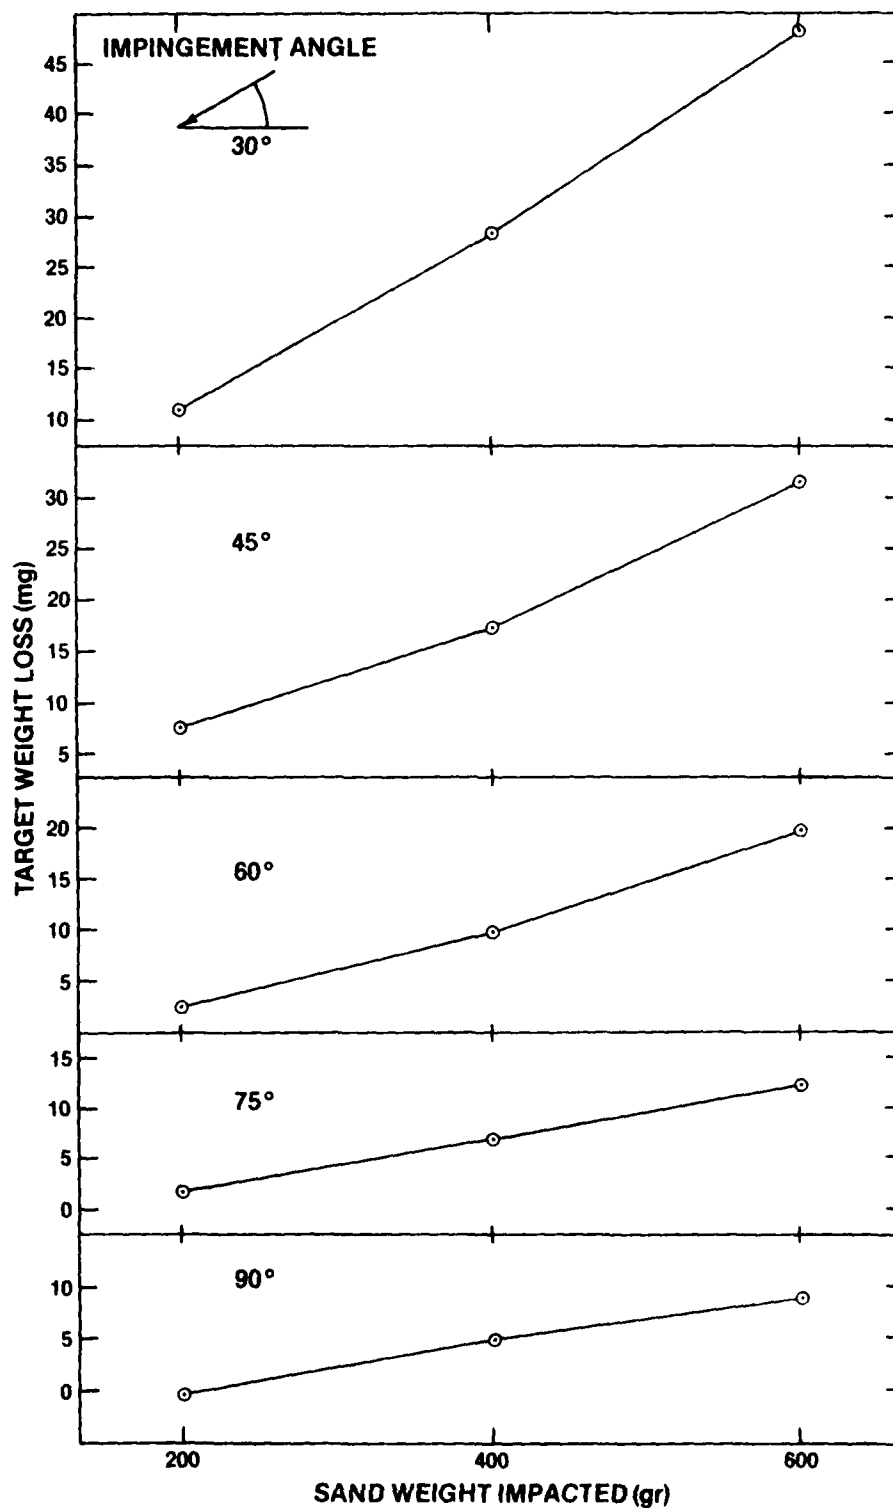
Fig. 3.11 Weight Loss of MIL-C-83286 Polyurethane/E Glass Epoxy as a Function of Sand Weight Impacted

A correlation between weight change of polyurethane coating on E Glass Epoxy substrate (AFWAL/MLBE) and the amount of sand particles impacted at constant impingement angles is shown in Figure 3.11 and 3.12 for MIL-C-83286 polyurethane and MIL-C-83231 polyurethane, respectively. Figure 3.12 shows that increasing the amount of sand weight impacted in the range of 200 to 600 gr resulted in an increase of target weight loss for the hard polyurethane. Moreover, the rate (i.e., the amount of target weight loss to amount of sand impacted) decreased from

a maximum value at impact angle of 30° to a minimum at 90° (Figure 3.11).

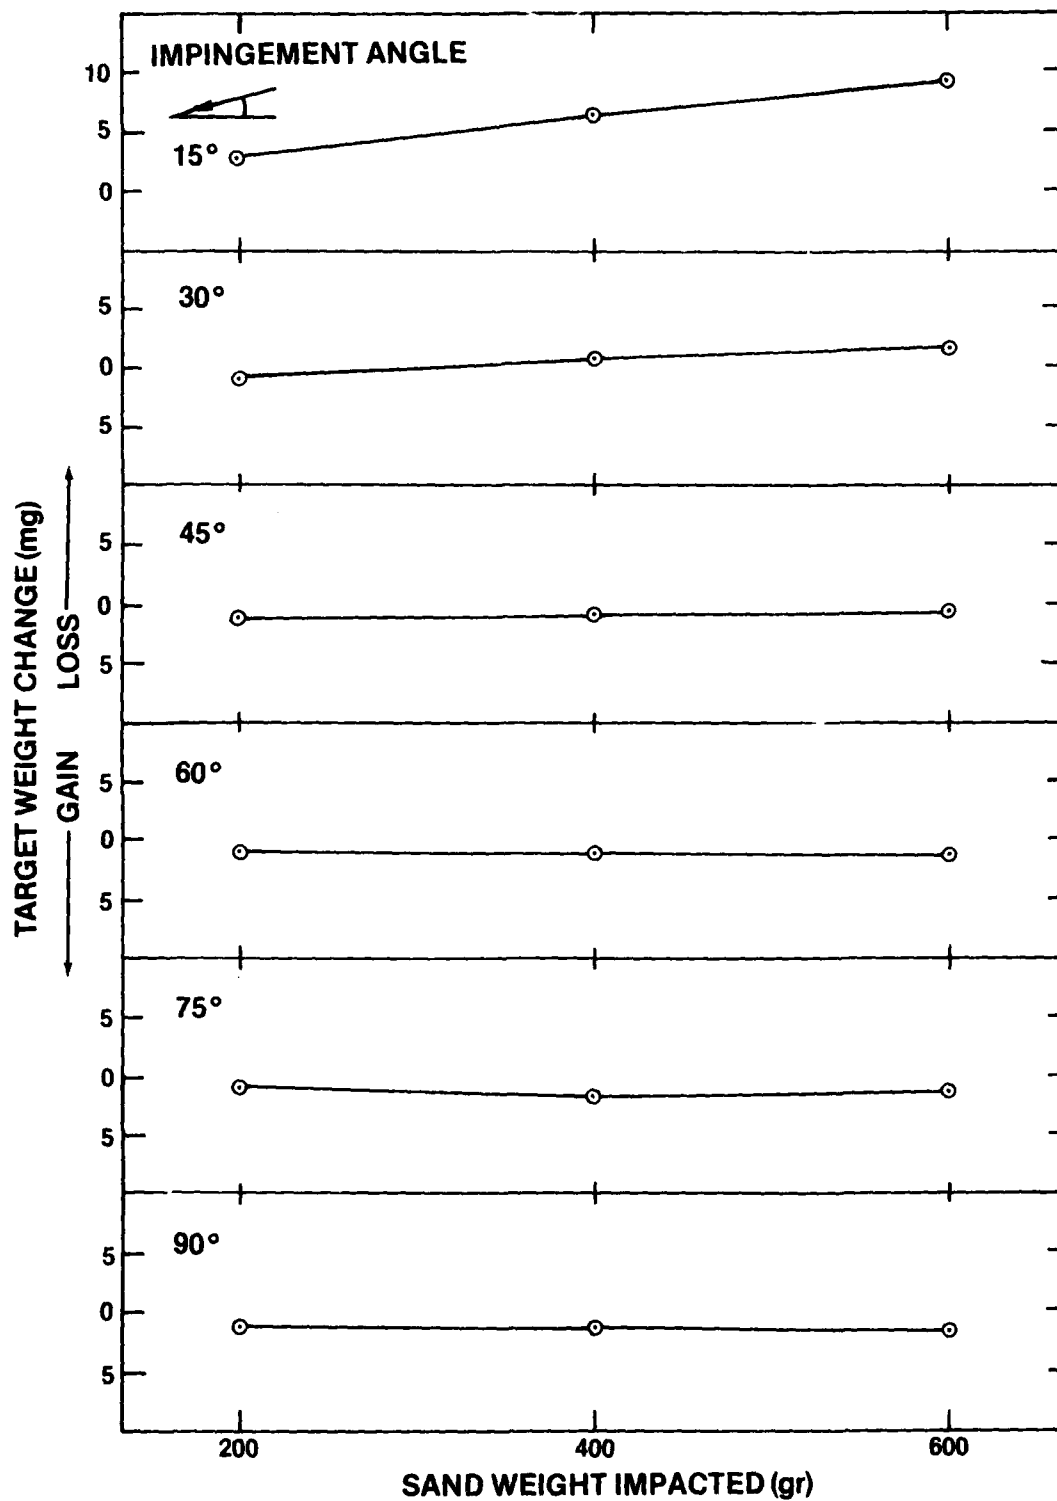
Fig. 3.12 Weight Change of MIL-C-83231 Polyurethane/E Glass Epoxy as a Function of Sand Weight Impacted

The MIL-C-83231 elastomeric polyurethane coating was found to behave differently compared to the MIL-C-83286 polyurethane under the same erosion condition. As shown in Figure 3.12, weight changes of MIL-C-83231 polyurethane coatings were found to be independent of the amount of sand impacted (200 gr to 600 gr) under impact angles of 45° to 90° . At lower impact angles of 30° to 45° a linear increase of target weight loss was found. Moreover, increasing weight gain rather than loss was found in this coating when increasing the amount of sand impacted at constant impact angles of 45° to 90° .

Elastomeric coatings materials like polyurethane MIL-C-83231 and fluorocarbon AF-C-VBW-15-15 were also affected by impact angle. For low incident angles of 15° and 30° , target weight loss was maximum but it was reduced to a minimum (near zero) at 30° - 45° . At higher impact angles from 45° to 90° , only weight gain was observed and this was independent of impact angle in the case of the polyurethane material (Figure 3.9 and 3.10). This weight suggests the embedment of sand particle fragments at the target eroded surface. Furthermore, the effect of amount of sand impacted on target weight loss showed that at impact angles in the range 45° to 90° , the target material gained weight rather than lost, independent of amounts of sand weight impacted (Figure 3.12 and 3.13).
